NASA TM X-3252

THE EFFECTS OF ENVIRONMENTAL EXPOSURE
ON REUSABLE SURFACE INSULATION
FOR SPACE SHUTTLE

Philip O. Ransone

J. D. Morrison

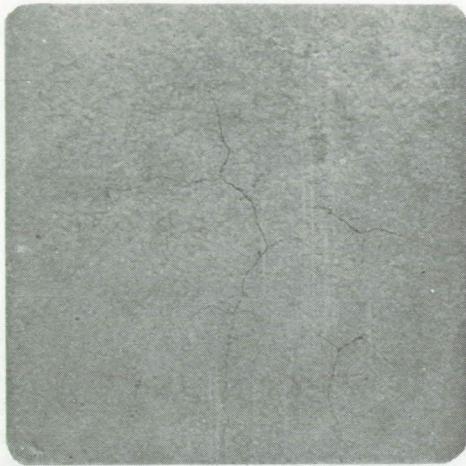
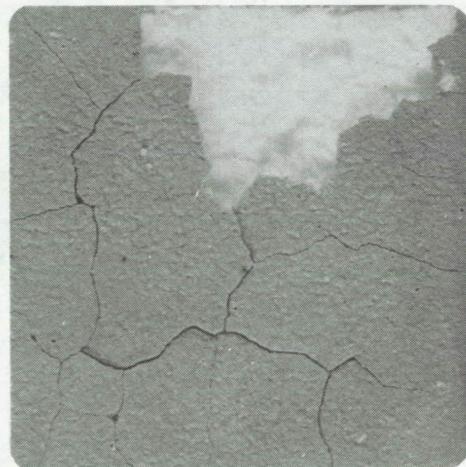
Figure 11 shows two launch-site specimens after twenty-nine and thirty-eight 1-week exposures and temperature cycles. Comparison of these specimens with the 2-week exposure group of figure 10 shows that cracking commenced after approximately the same total atmospheric exposure time (30 weeks) even though the 1-week exposure group had experienced about twice as many temperature cycles. Therefore, figures 10 and 11 show that cracking depends on time exposed to environment rather than number of cycles. They also show that specimens exposed to water impingement (i.e., specimens on top side) suffered the most degradation by eruption failure and/or macrocracking.

Devitrification. - The specimens shown in figures 10 and 11 were analyzed for devitrification. The spalled areas on the lower right or 4th quadrant surface of specimen 9 resulted from crumbling of the coating, while other damaged areas resulted from eruption failures that did not extend through the sublayer of coating. The coatings of specimens 9 and 16 were found to be very friable when they were removed from specimens for X-ray diffraction analysis. Analysis revealed that these coatings contained about 85 percent by weight cristobalite which would account for the extreme friability of the coating. (Friability is characteristic of devitrified glass bodies.) Specimen 10 did not show an appreciable amount of cristobalite after 18 cycles. As indicated previously, this was the only specimen of its group which did not crack after 18 cycles and was the only one of its group which was not exposed to water impingement. Specimen 5 which was exposed to water impingement, qualitatively indicated a high cristobalite content (probably 80 to 90 percent).

On the other hand, specimen 6 which was not exposed to water impingement, qualitatively indicated much less cristobalite.

Slight sagging of the test faces on all specimens shown in figures 10 and 11 was noted. This sagging was not attributed to devitrification of the coatings but rather to shrinkage of the underlying insulation. Sagging was evident on nearly all specimens, clean or contaminated, after 12 to 15 cycles.

Figure 11.- Cracking failures in LI-0042 coating. One-week launch-site exposures;
38 heating cycles (table I).
